# Conditions for DBDS Induced Corrosive Sulfur Formation.

Hydroelectric power plant. Transformer data:

1999 GSU.	75 MVA 11/220 kV.
Oil weight: 36000 kg.	Oil make Shell Diala DX.
Cooling ONAF.	The unit is sealed.

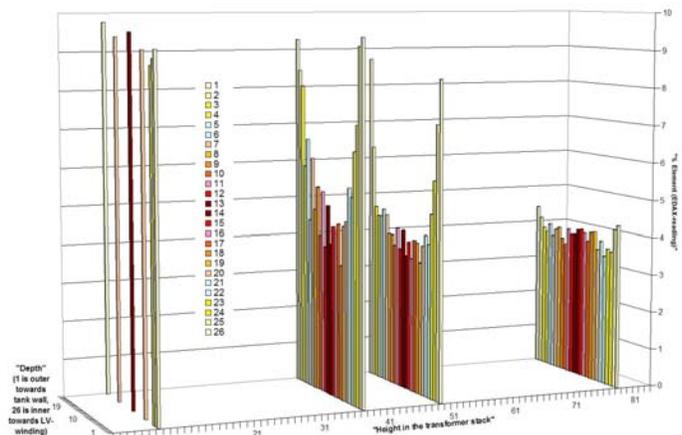
The adsorbed oxygen is unreacted and remain on the conductor surface on the lower winding levels but the higher up in the winding stack the less oxygen is left unreacted.

Very little sulfidation on the lower layer and on the radially innermost and outer-most of the windings except for the top layer which has an even and complete copper sulfide covering .

Oxygen fraction in (%) on conductor surface.

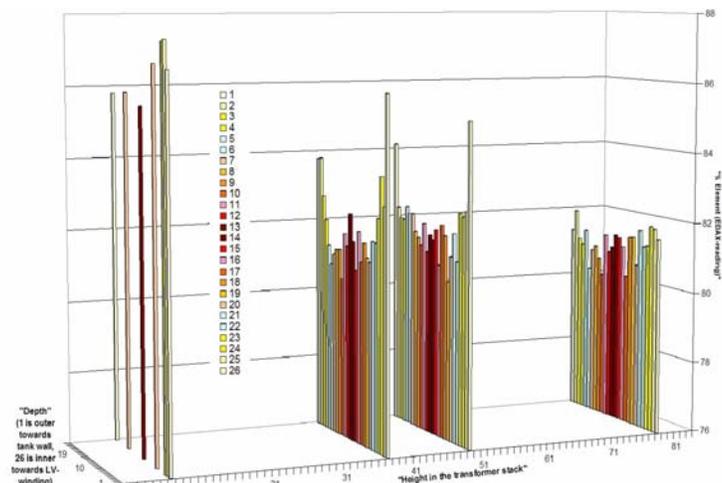
Copper distribution as measured in SEM (EDAX).

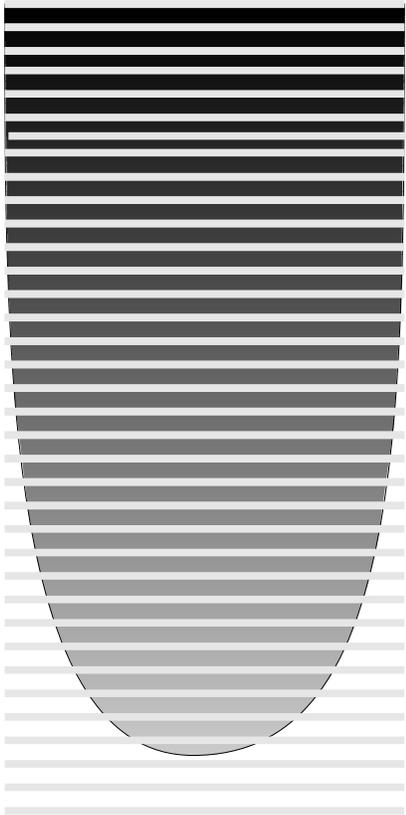
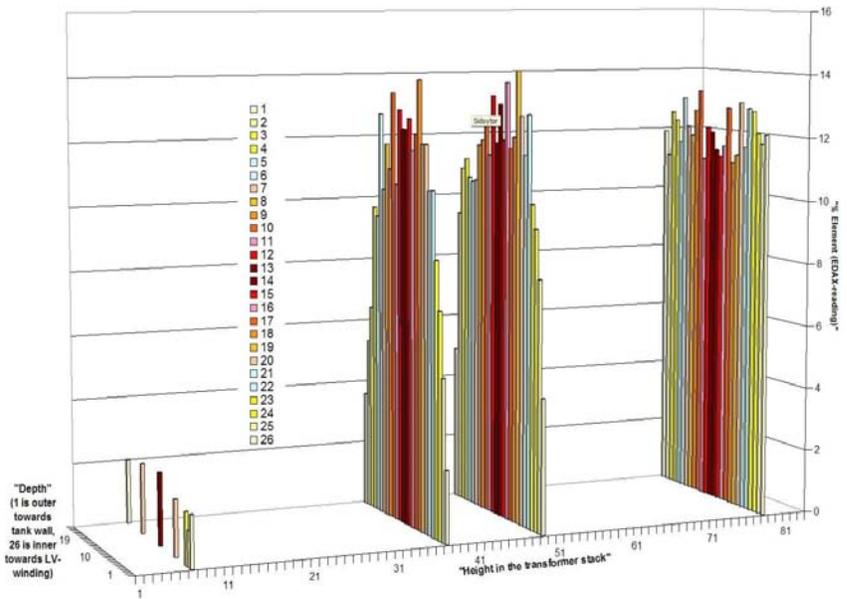
*Sulfur distribution.*

The distribution is evidently completely in agreement with the temperature distribution expected for a transformer.

Low temperature; no sulfidation attack, high temperature (active copper); strong sulfidation attacks.

If the operating temperature would have been at this level or less, **the transformer would not have failed due to copper corrosion**.

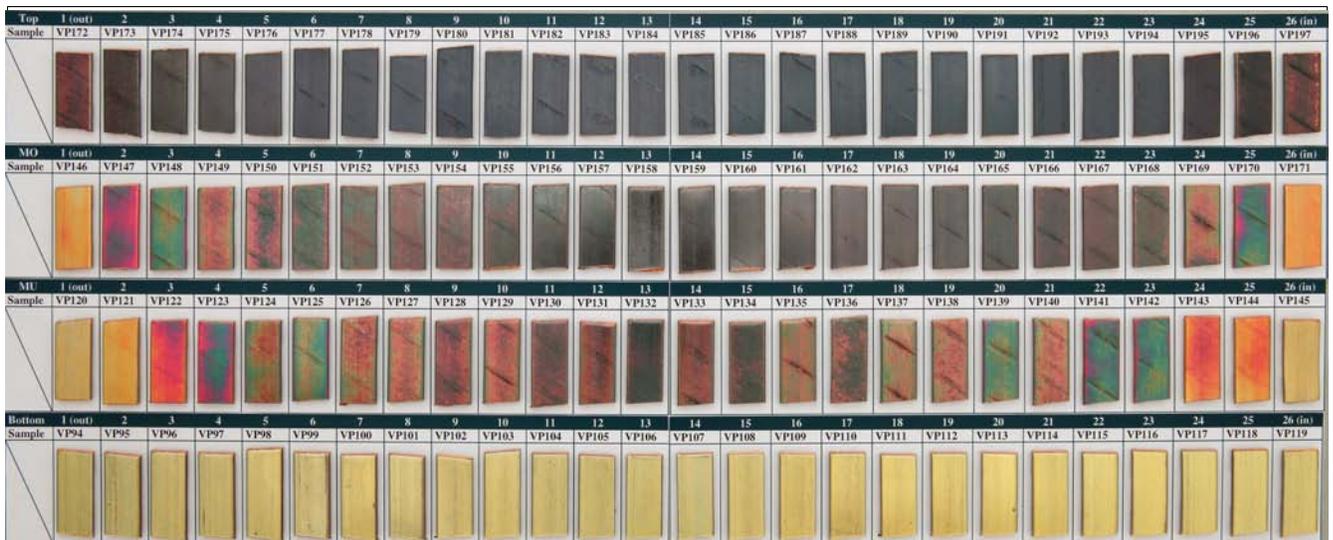
The picture and sketch speaks for themselves; **the temperature influence is obvious.**

Pieces of copper winding taken from different "heights" in a stack of winding in a transformer supposedly failed due to corrosive sulfur (manufacturers statement). It must be pointed out that the fault section of this transformer was not available for for us to inspect. 104 different winding sections were diagnosed.

If the copper surface would have been enameled no corrosion attacks would have been possible.
